Cure Evaluation of Two Critical Composite Hybrid Flat Panels for use in a High-Dimensional Stability Satellite Application

20 July 2003

R. J. ZALDIVAR and R. CASTENEDA
Space Materials Laboratory
Laboratory Operations

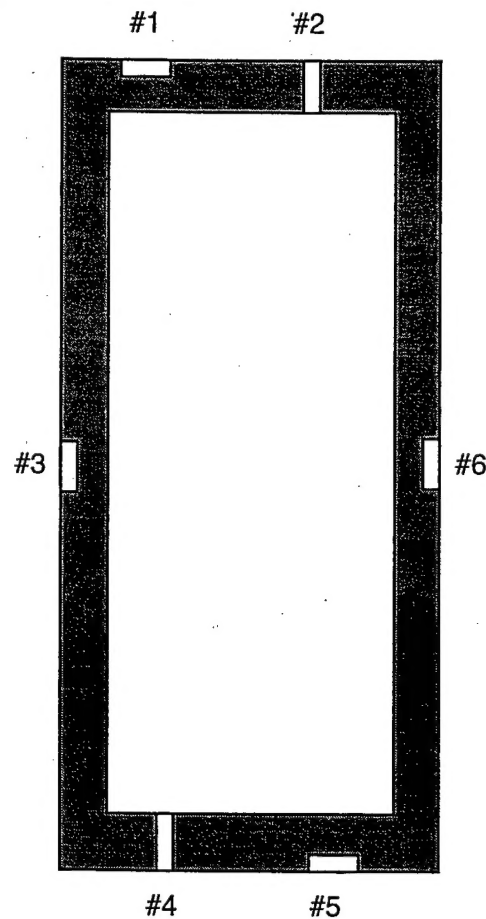
Figure 1. Schematic of composite panel tested in our investigation along with location of tag ends used for dynamic mechanical analysis testing. Gray area denotes problematic portion of laminate (window frame area) as evidenced by solvent wipe test.

The tag end samples were cut from the actual panels, as shown in Figure 1. The residue is believed to be concentrated on the outer 2 in. of the sample, similar to a window pane trace. Each of the tag end samples was tested using dynamic mechanical analysis (DMA). Each of the samples designated 1-6 was tested in two different modes. The entire thickness of the sample was tested, and only the outer few plies of specimens were also tested. Our previous studies have shown that contamination may be localized in the few outer plies, and measurements of Tg on the entire samples may be misleading unless severe degradation has occurred. Either way, if it is a surface effect or the entire sample has been affected, bonding onto this panel will make it prone to premature mechanical failure.

At this time, we don't know whether both panels were fabricated using the same lots of material. Flatwise tension tests should still be performed to ensure that good consolidation of the panel has occurred; however, the cure state is satisfactory, and we see no reason to discard Panel 2. To assure highest reliability, Panel 2 should be machined 1.0 in. from the outer perimeter to remove any contaminated material.

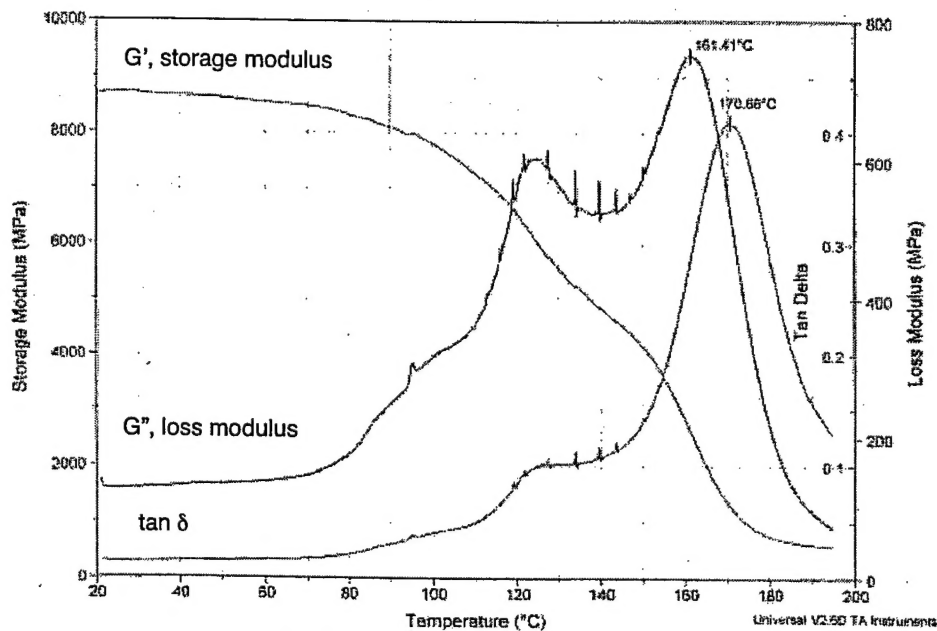
Figure 3 shows a DMA scan for panel 1. This scan shows the loss modulus as a function of temperature. Typically, the peak value for the loss modulus indicates the T_g. This material should produce a single loss modulus peak centered at about 170–175°C. As shown, the loss curve appears to be a combination of a number of peaks. This is usually an indication of severe hydrolysis contamination. As shown, there is a shoulder at 100, a peak at 125, and one at 165°C. This scan describes a resin system that is not only undercured but has regions cured to varying degrees. In other words, portions of the network have cured significantly while others are only slightly branched. Upon heat-treatment exposure, the lower crosslinked areas of the polymer are easily softened and cannot resist thermal degradation. Not only is this polymer system only partially cured, the hydrolysis of the system creates a more linear, less compliant matrix material that is different in chemical structure than what was intended. This DMA scan indicates serious moisture contamination. Additional heat treatments would have no effect on advancing the resin further or improving crosslinking density. Samples from this panel were placed in a solvent batch for a specific length of time as described in a previous publication.² The system was observed to completely dissolve within 5 min. Well-cured systems will not dissolve, even after exposure up to 5 h.

Figure 3. Typical DMA scan of Panel 1 on the outside edges.

Table 1 shows a compiled list describing the measured Tg values for the many tag end samples from Panel 1. As shown and described previously, there are a number of multiple Tg values for each tag end. This indicates severe moisture contamination. Samples 2 and 4 represent areas of the panel 0.05, 1.0, and 2.0 in. from the outer edge. The Tg values increase as the samples move in a few inches from the outer edges. However, even at a 2.0-in. depth, the resin still appears compromised. A Tg value of 165°C for this resin has been shown in previous publications to be both mechanically and thermally affected. Tag-end samples 3, 5, and 6 indicate changes in Tg values from the edge of the sample to 1.0 in. from the edge into the panel. Again, the values indicate an increase in Tg, showing improvement, but significantly lower than a well-cured material. The samples (1, 3, 5, and 6) tested laterally around the perimeter of panel 1 were shown to be quite consistent. The entire panel appeared to be hydrolyzed to the same degree on the outer sections. The Tg data for this panel shows that this composite was severely affected during cure. Mechanical flatwise tension tests are currently being performed, and the contractor has stated that preliminary data shows a higher-than-expected degree of scatter and low strengths. Once the resin becomes hydrolyzed during cure there is no remedy to obtain full cure. The by-products created during hydrolysis prevent a well-crosslinked, fully cured end product. Multiple peaks in the Tg curves for most tag ends led us to recommend scrapping the panel. Other issues, such as severe microcracking, thermal expansion coefficients, moisture absorption and thermal capabilities, will be affected.

- We do not recommend using Panel 1 due to the severe degree of contamination that has occurred to the composite. Bonding to the surface of the composite may greatly affect mechanical performance. However, Panel 2 appears to be fairly well cured, especially 1.0 in. in from the outer perimeter. Panel 2 appears satisfactory for use with respect to its degree of cure. Additional, flatwise tension tests should be performed to evaluate variability and strength.

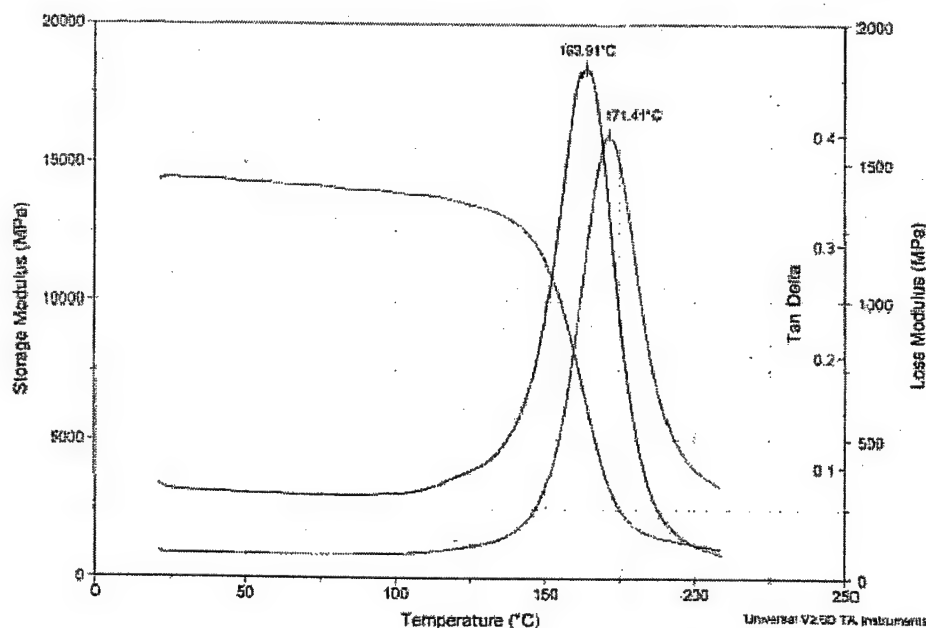
Table 2 shows a compiled list describing the Tg values for the tag end samples from Panel 2. As shown and in contrast to panel 1, all of the samples for panel 2 had only one single sharp peak for the loss modulus. The DMA scan shown in Figure 3 shows this loss modulus peak, which represents the glass-transition temperature of the material. Samples 2 and 4 represent areas of the panel moving in from the outer edge. As shown, the Tg values show a slight increase in Tg as we move into the bulk of the panel. The slightly lower Tg on the outer perimeter may be due to some hydrolysis of the polymer. However, the Tg values are all quite high and above the values that

Figure 4. Typical DMA scan of Panel 2 on the outside edges.

are indicative of a well-cured system. The other Tg values taken from the tag ends around the perimeter of the panel indicate minimal changes and that full cure has occurred. The overall cure state of Panel 2 appears to be sound. It is quite surprising that the state of Panel 1 is so degraded in comparison to Panel 2 since both panels were processed simultaneously.

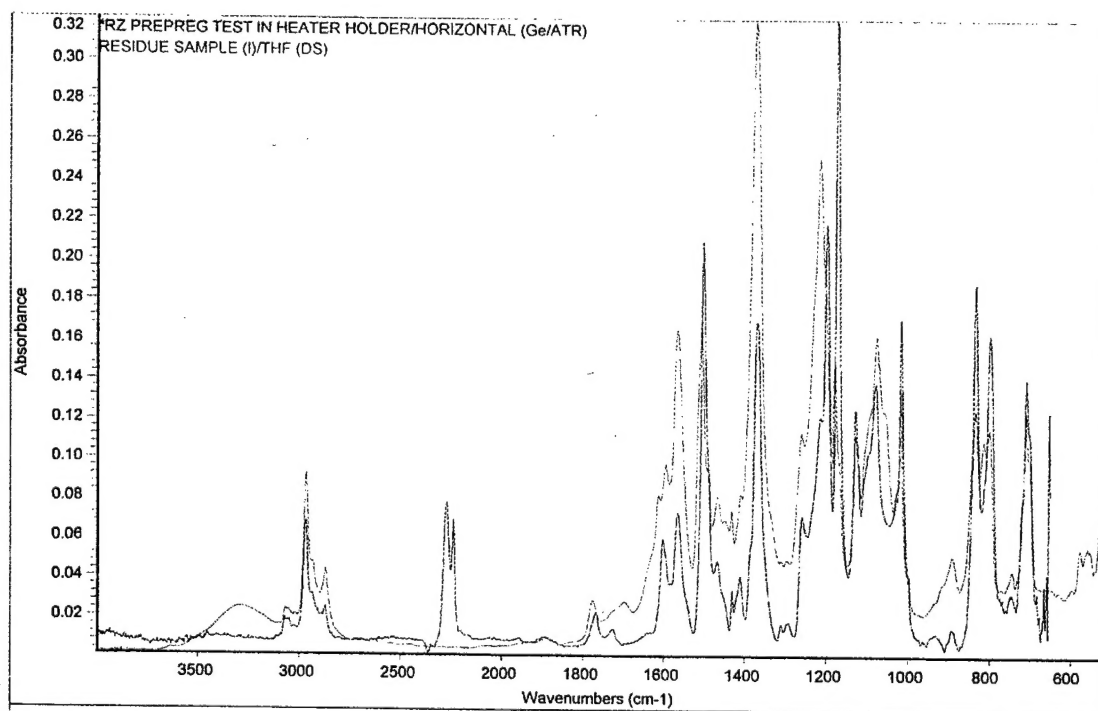
The third peak to focus on is located at approximately 1750 cm^{-1} . This is a carbonyl peak that is usually indicative of hydrolysis of the cyanate ester occurring during the polymerization process. This type of carbamate contamination is the primary cause for large variations or decreases in the glass-transition temperature of the resin, even after heat treatment to high temperature. Figure 7 shows a typical FTIR with limited contamination.

Figure 7. FTIR spectra showing indications of limited moisture contamination during cure. Blue spectra shows uncured system to emphasize differences in spectra.

1560 cm^{-1} for all parts taken from Panel 1 and Panel 2. Panel 2 appeared fully cured for all specimens and showed no evidence of hydrolysis contamination, which corroborates our measured Tg data. Panel 1, however, indicated a composite part that ranged in the degree of cure from 70 to 90%, depending on the location measured. The areas with the lowest degree of cure showed indications of carbamate formation. Even though by-products of hydrolysis were observed, the degree could not be easily quantified due to the convoluted nature of the peak.
